New Hampshire Volunteer Lake Assessment Program

2002 Bi-Annual Report for Ayers Pond Barrington

NHDES
Water Division
Watershed Management Bureau
6 Hazen Drive
Concord, NH 03301

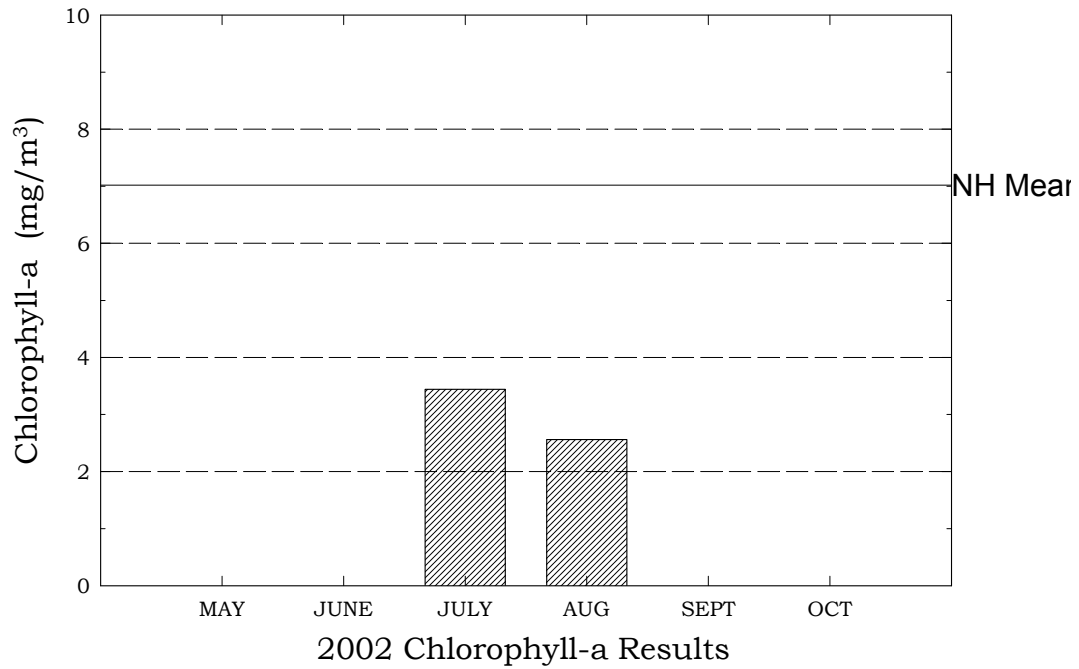
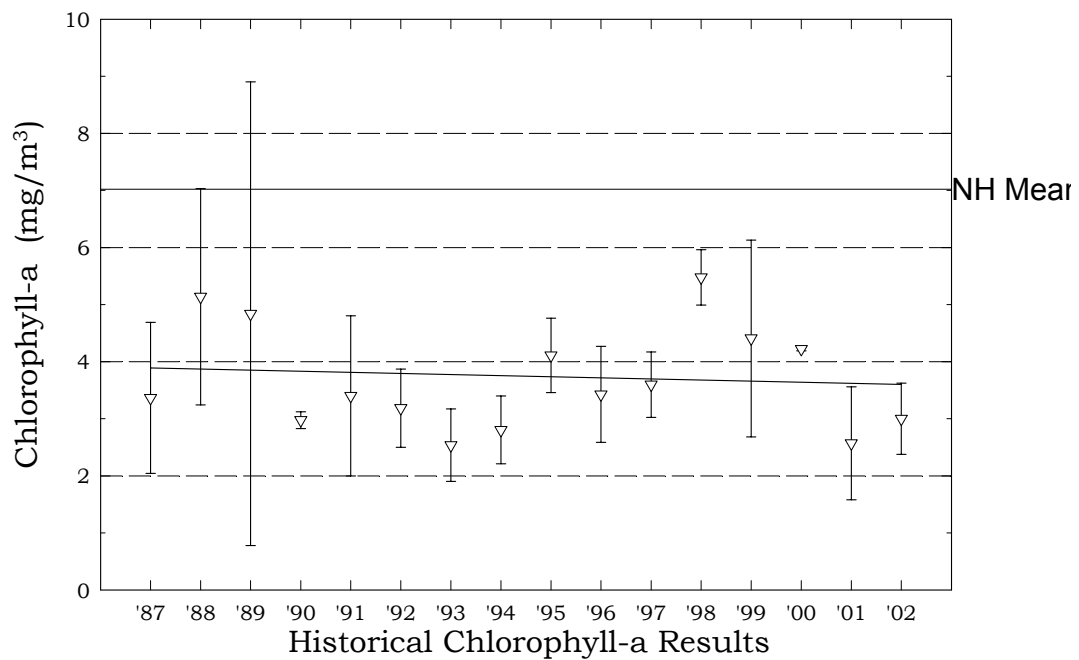
Figure 1. Monthly and Historical Chlorophyll-a Results

- **Figure 1 and Table 1:** The graphs in Figure 1 (Appendix A) show the historical and current year chlorophyll-a concentration in the water column. Table 1 (Appendix B) lists the maximum, minimum, and mean concentration for each sampling season that the lake/pond has been monitored through the program.

The current year data (the top graph) show that the chlorophyll-a concentration **decreased** from July to August.

The historical data (the bottom graph) show that the 2002 chlorophyll-a mean is ***much less than*** the state mean.

Overall, the statistical analysis of the historical data (the bottom graph) shows that the mean annual chlorophyll-a concentration has ***not significantly changed*** (either *increased* or *decreased*) since monitoring began in **1987**. Specifically, the chlorophyll-a concentration has remained ***relatively stable*** and has been ***much less than*** the state median. (Note: Please refer to Appendix E for the detailed statistical analysis explanation and data print out.) We hope this trend continues!

While algae is naturally present in all lakes/ponds, an excessive or increasing amount of any type is not welcomed. In freshwater lakes/ponds, phosphorus is the nutrient that algae depend upon for growth. Therefore, algal concentrations may increase when there is an increase in nonpoint sources of nutrient loading from the watershed, or in-lake sources of phosphorus loading (such as phosphorus releases from the sediments). It is important to continually educate residents about how activities within the watershed can affect phosphorus loading and lake quality.

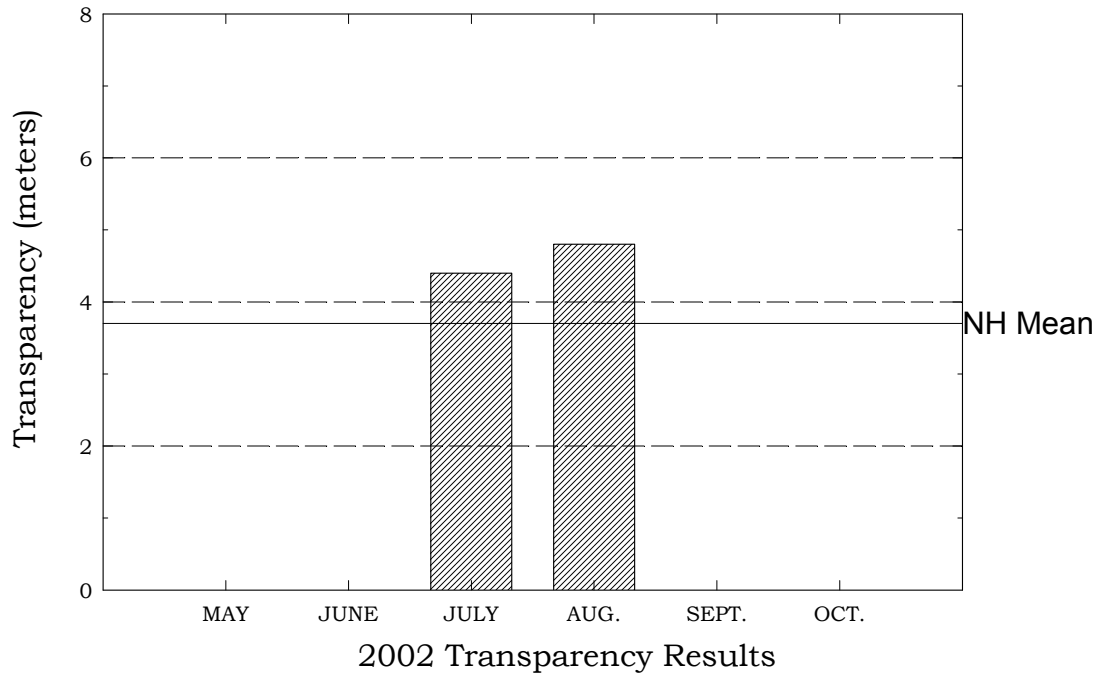
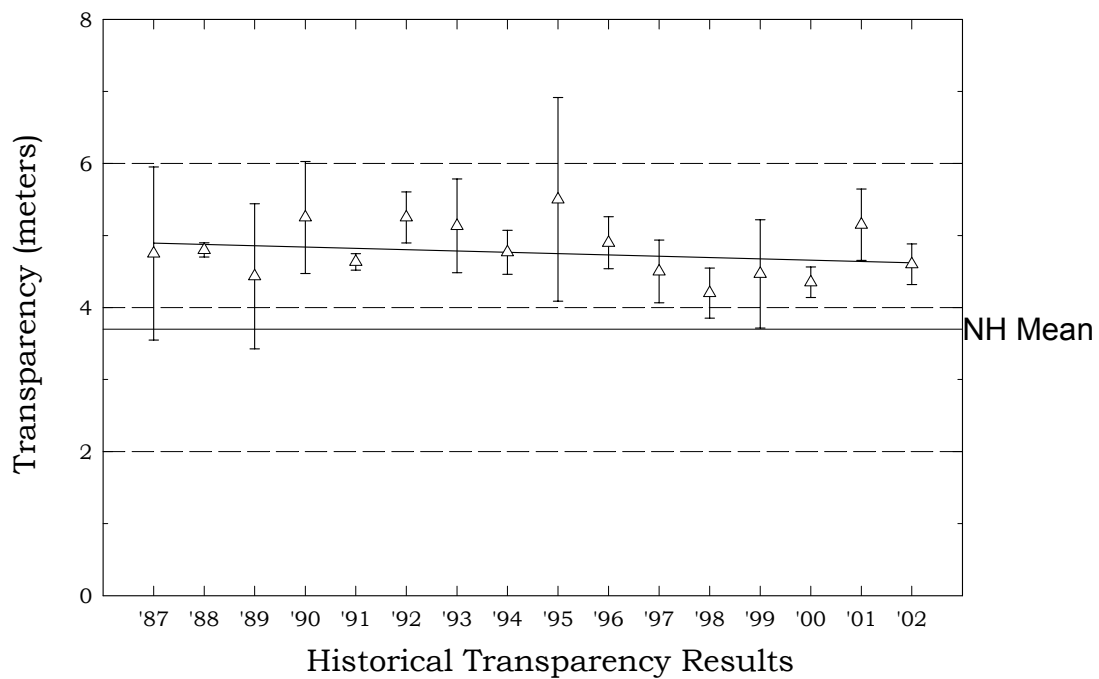
Figure 2. Monthly and Historical Transparency Results

- **Figure 2 and Table 3:** The graphs in Figure 2 (Appendix A) show historical and current year data for lake/pond transparency. Table 3 lists the maximum, minimum and mean transparency data for each sampling season that the lake/pond has been monitored through the program.

The current year data (the top graph) show that the in-lake transparency **increased slightly** from July to August. It is interesting to note that as the chlorophyll-a concentration decreased from July to August, the transparency increased. We typically expect this relationship in lakes and ponds. As the concentration of algal cells decreases, the transparency typically increases.

The historical data (the bottom graph) show that the 2002 mean transparency is **slightly greater than** state mean.

Overall, the statistical analysis of the historical data (the bottom graph) show that the mean annual in-lake transparency has **not significantly changed** (either *increased* or *decreased*) since monitoring began in **1987**. Specifically, the in-lake transparency has remained **relatively stable** and has been **slightly greater than** the state mean. (Note: Please refer to Appendix E for the statistical analysis explanation and data print out.)

Typically, high intensity rainfall causes erosion of sediments into lakes/ponds and streams, thus decreasing clarity. Efforts should continually be made to stabilize stream banks, lake/pond shorelines, disturbed soils within the watershed, and especially dirt roads located immediately adjacent to the edge of tributaries and the lake/pond. Guides to Best Management Practices designed to reduce, and possibly even eliminate, nonpoint source pollutants, such as sediment loading, are available from NHDES upon request.

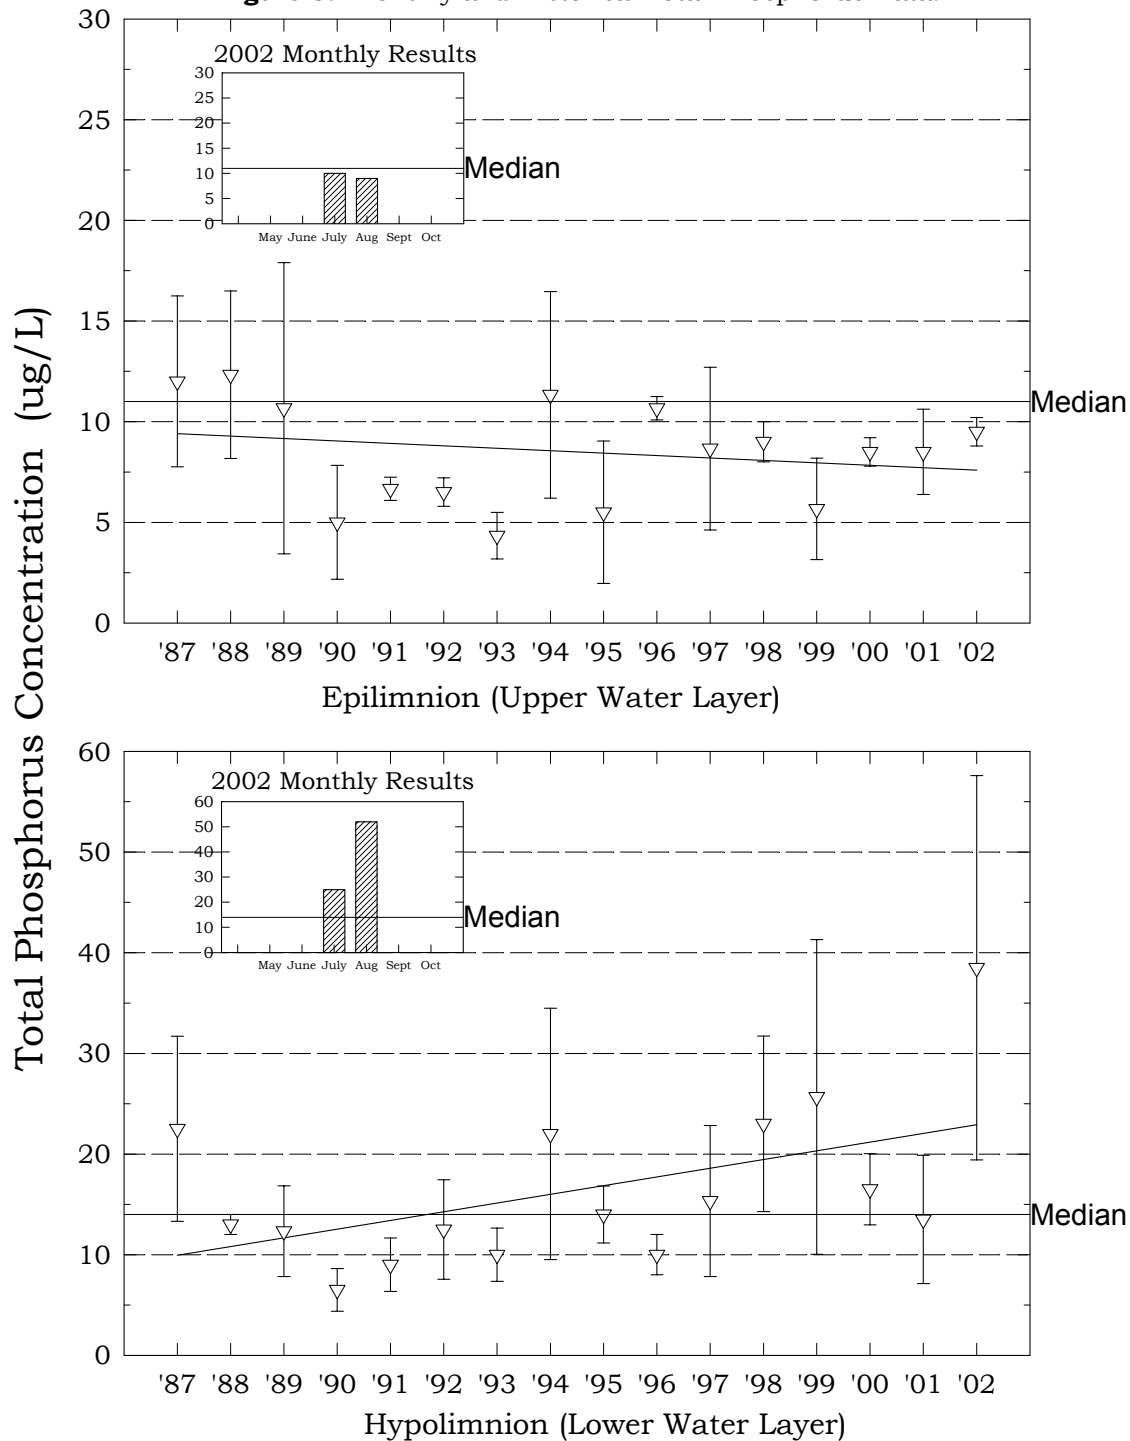
Figure 3. Monthly and Historical Total Phosphorus Data.

- **Figure 3 and Table 8:** The graphs in Figure 3 (Appendix A) show the amounts of phosphorus in the epilimnion (the upper layer) and the hypolimnion (the lower layer); the inset graphs show current year data. Table 8 (Appendix B) lists the annual maximum, minimum, and median concentration for each deep spot layer and each tributary since the lake/pond has joined the program.

The current year data for the epilimnion (the top inset graph) show that the total phosphorus concentration **decreased slightly** from July to August and was **slightly less than** the state median on each sampling event.

The current year data for the hypolimnion (the bottom inset graph) show that the total phosphorus concentration **increased greatly** from July to August, and was **greater than** the state median on each sampling event. (It is important to note that the turbidity of the hypolimnion was very high on the August sampling event (27.2 NTUs). This suggests that the lake/pond bottom may have been disturbed by the anchor or by the Kemmerer Bottle while sampling. When the lake/pond bottom is disturbed, sediment, which typically contains attached phosphorus, is released into the water column. When collecting the hypolimnion sample, please check to make sure that there is no sediment in the Kemmerer Bottle before filling the sample bottles.)

Overall, the statistical analysis of the historical data show that the total phosphorus concentration in the epilimnion (upper layer) and the hypolimnion (lower layer) has **not significantly changed** (either *increased* or *decreased*) since monitoring began in **1987**. Specifically, the total phosphorus concentration in the epilimnion has remained **relatively stable** and has been **approximately equal to** the state median.

However, it is important to note that the statistical regression results for the lower layer historical phosphorus data approached (but did not pass) the value necessary to conclude that there *has been* a statistically significant increase in the mean annual total phosphorus concentration at this station during the sampling period 1987 – 2002. (Refer to Appendix F for a more detailed explanation regarding statistical analysis). Although the results of the regression test

presently show that the increase in the mean annual total phosphorus concentration in the lower layer is not statistically significant, if the mean total phosphorus concentration in the lower layer continues to slightly increase each season at this station, the increase may soon become statistically significant. Therefore, it is important to continue to educate watershed residents on the ways to reduce phosphorus loading into the lake, and to continue to implement best management practices throughout the watershed.
